Phase 1, Task C and D
Contract DAAJ02-67-C-0048
March 1968

INVESTIGATION OF MATERIALS
TO RESIST HOT CORROSION
IN SMALL GAS TURBINE ENGINE RECUPERATORS

Third Quarterly Report
December 1, 1967 to February 29, 1968
AiResearch Report HT-67-2512(3)

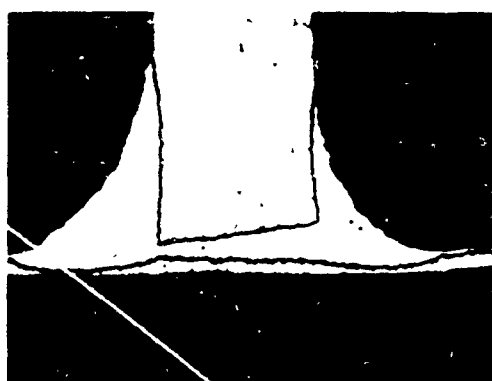
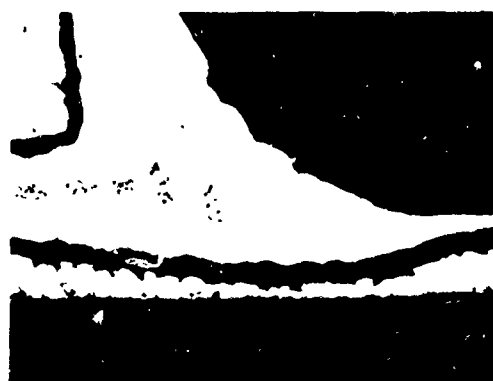
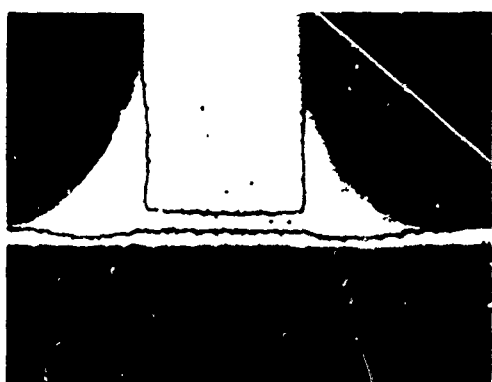
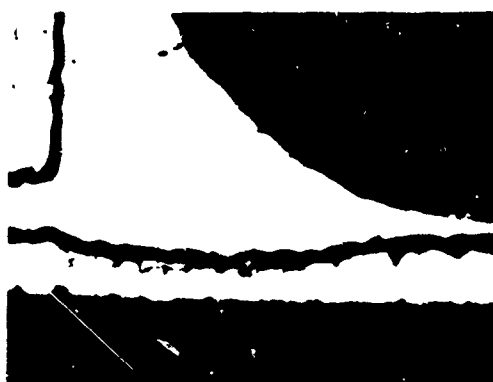
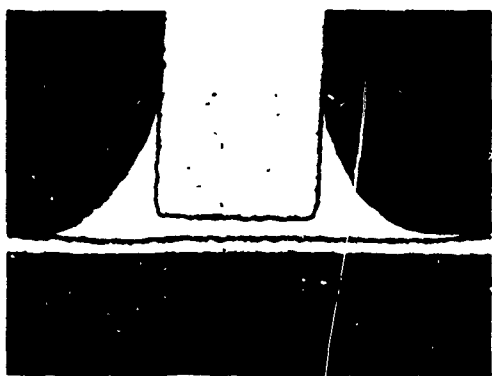
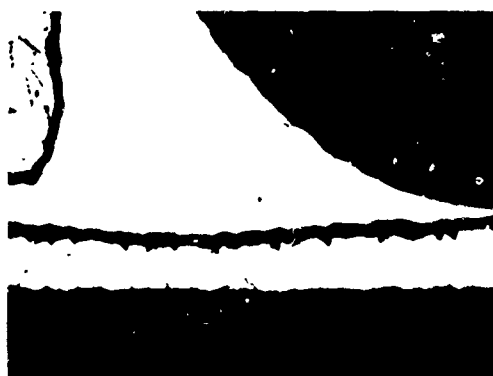
Figure 1. Photomicrographs of Hastelloy X Tube-Header Joints Brazed with Palnir 4 Brazing Alloy, in Vacuum, with a 10 Minute Hold Time at Temperature. Etched with Kalling's Reagent.

Metallographical evaluation of the brazed joints was completed and the results are summarized in Tables I through V. Photomicrographs illustrating the brazing characteristics at each brazing temperature for all of the combinations of candidate brazing alloys and tubing materials are presented in Figures 1 through 20. N-155 and Hastelloy X had the best brazing characteristics for the brazing alloys used followed closely by Incoloy 800 and CRES 347. Although the Incoloy 300 had a dull surface appearance after brazing caused by oxidation, it still brazed fairly well. Inconel 625 had a surface appearance similar to that of Incoloy 800. Wetting and filleting, however, was poorer on Inconel 625.

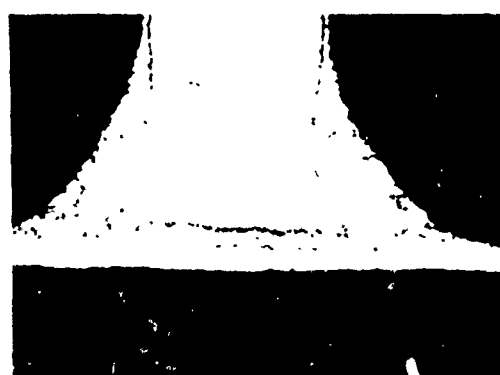
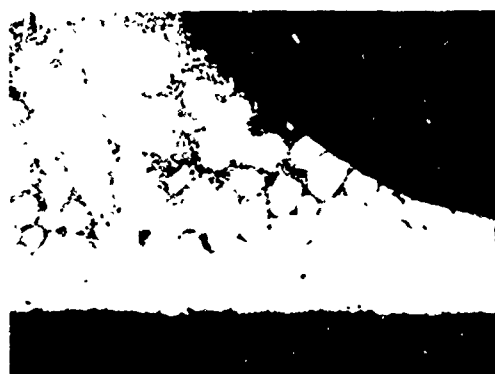
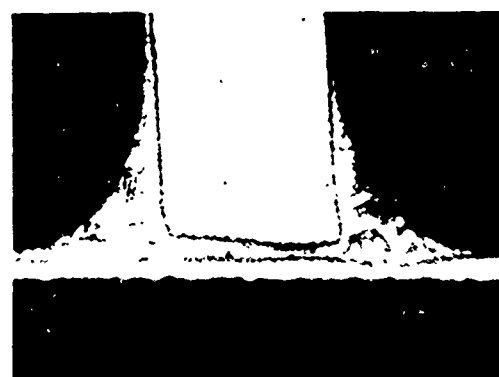
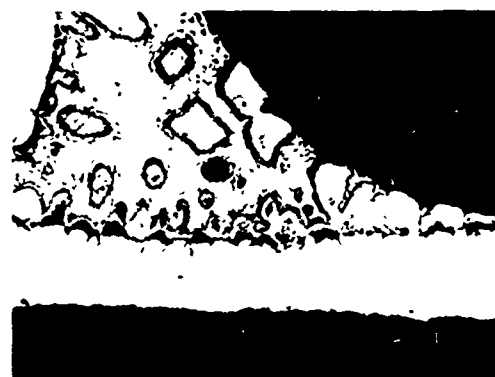
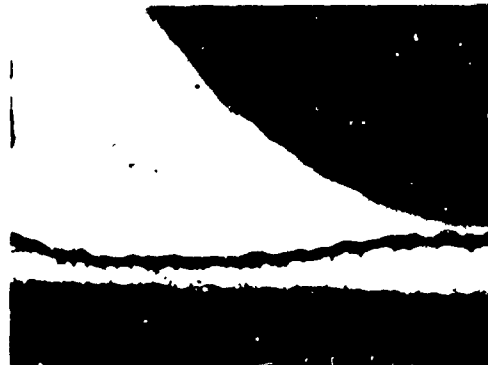
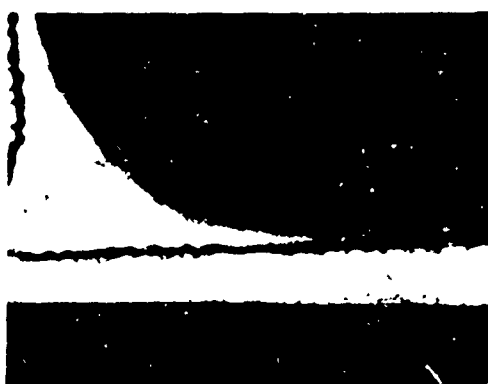
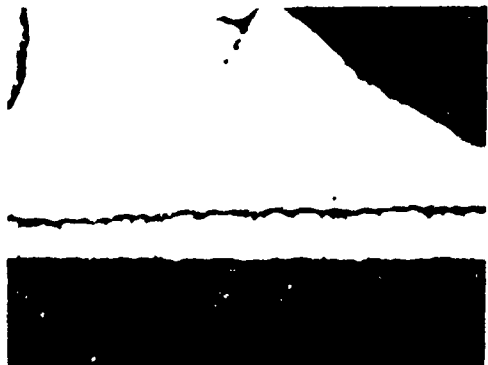
MAG 50X 1104

a. 217°F BRAZING TEMPERATURE.

MAG 150X 1105

b. 2175°F BRAZING TEMPERATURE

MAG 50X 975

e. 2125°F BRAZING TEMPERATURE

MAG 150X 976

f. 2125°F BRAZING TEMPERATURE.

MAG 50X 977
H. 2100°F BRAZING TEMPERATURE.

MAG 150X 978
I. 2100°F BRAZING TEMPERATURE.

MAG 150X 980
J. 2075°F BRAZING TEMPERATURE.

MAG 150X 982
L. 2050°F BRAZING TEMPERATURE.

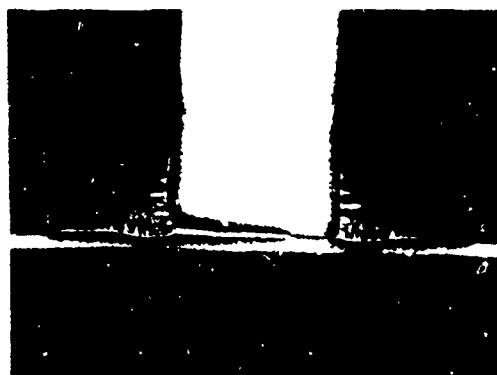
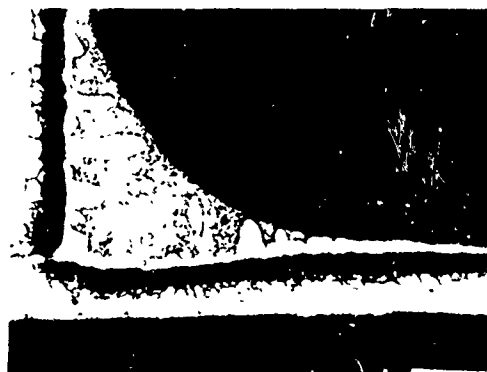
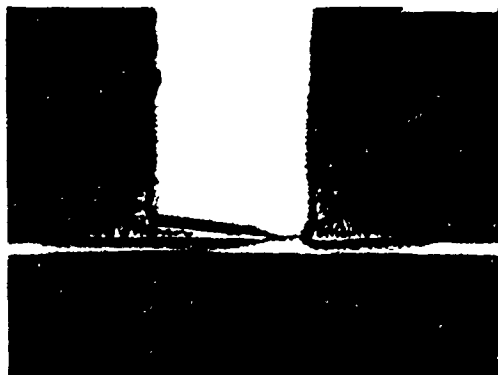
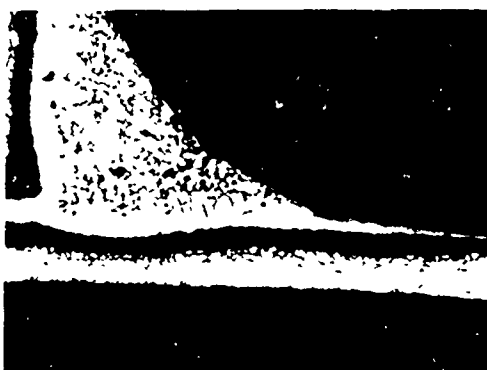
Figure 3. Photomicrographs of Hastelloy X Tube-Header Joints Brazed with Palnirio I Brazing Alloy, in Vacuum, with a 10 Minute Hold Time at Temperature. Etched with Kalling's Reagent.

MAG = 50X 933
a. 2025°F BRAZING TEMPERATURE.

MAG = 150X 984
b. 2025°F BRAZING TEMPERATURE.

MAG = 50X 985
c. 2000°F BRAZING TEMPERATURE.

MAG = 50X 987
e. 1975°F BRAZING TEMPERATURE.

MAG = 150X 988
f. 1975°F BRAZING TEMPERATURE.

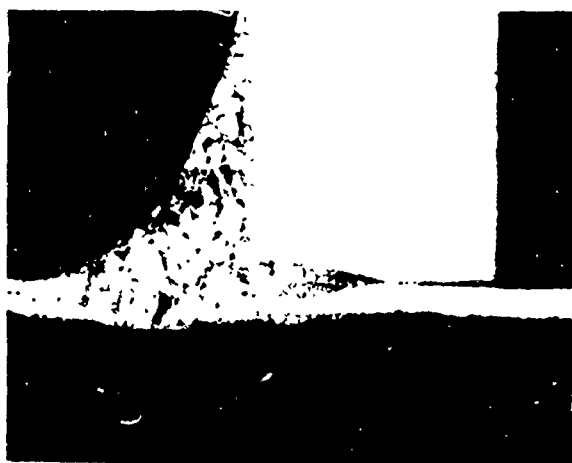
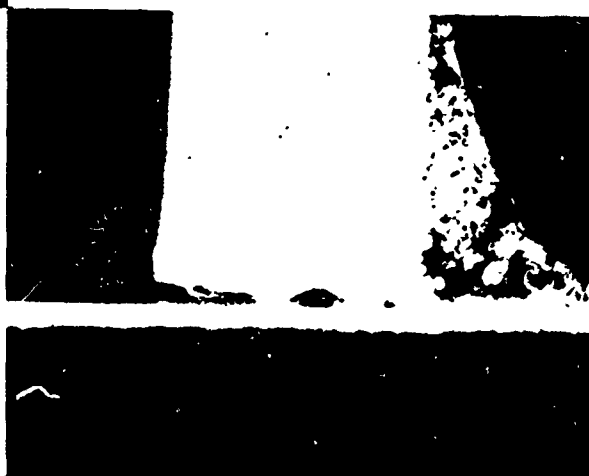
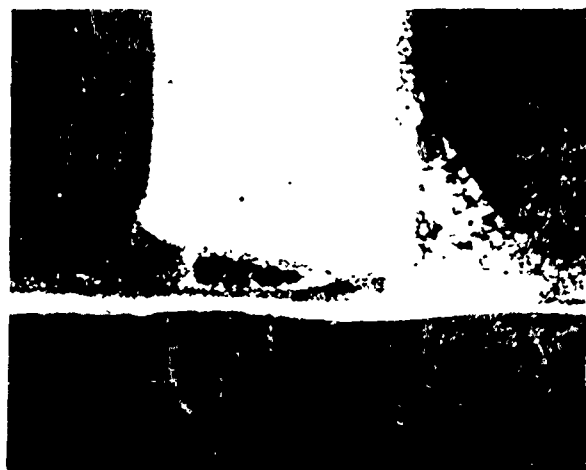
Figure 5. Photomicrographs of Inconel 625 Tube-Header Joints Brazed with J-8100 Brazing Alloy, in Vacuum, with a 10 Minute Hold Time at Temperature. Etched with Kalling's Reagent.

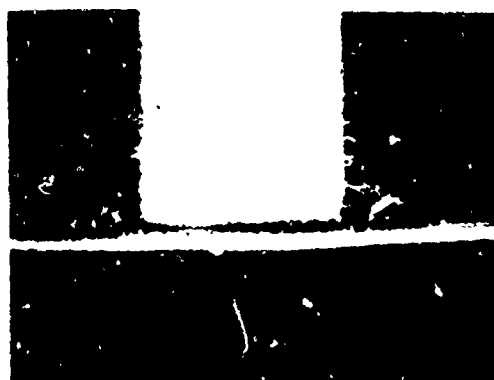
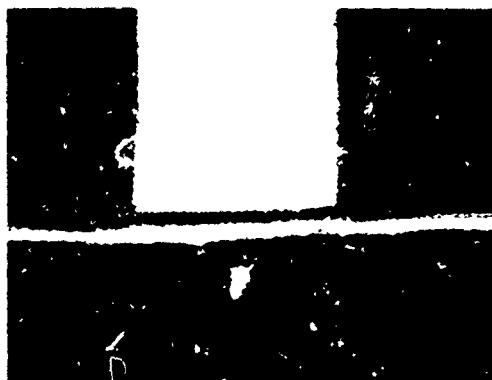
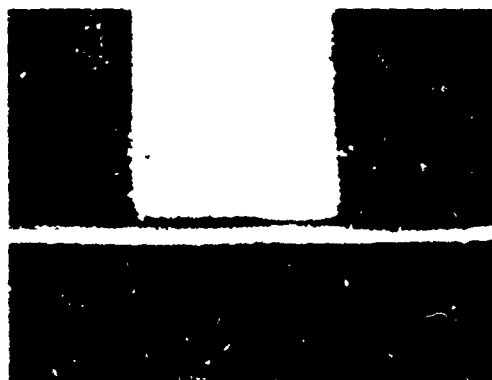
MAG 50X 992

a 2125°F BRAZING TEMPERATURE

MAG 50X 994

c 2100°F BRAZING TEMPERATURE

MAG 150X 995

d 2100°F BRAZING TEMPERATURE

MAG 50X 996

e 2075°F BRAZING TEMPERATURE

MAG 150X 997

f 2075°F BRAZING TEMPERATURE

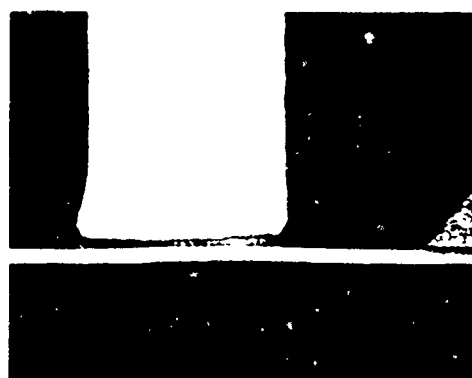
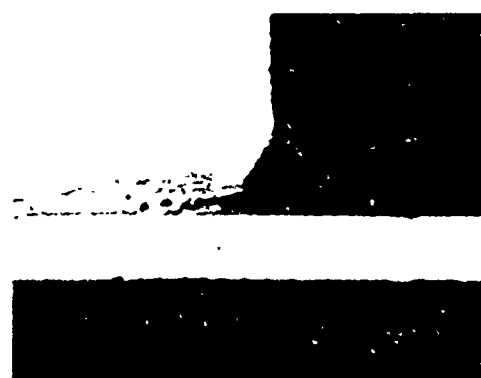
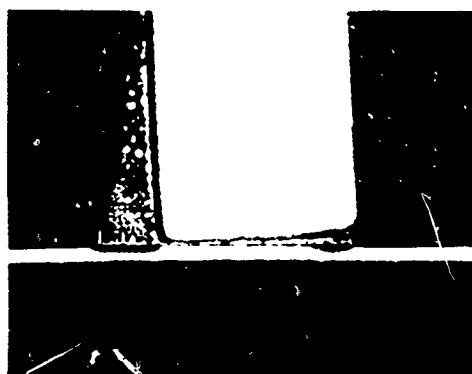
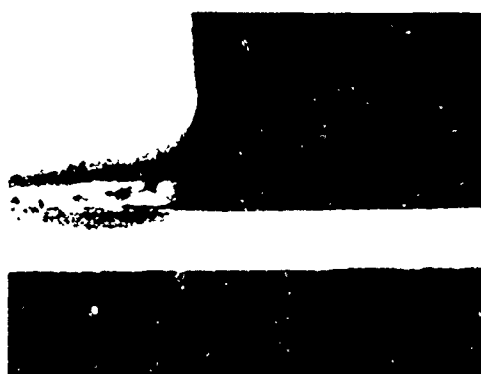
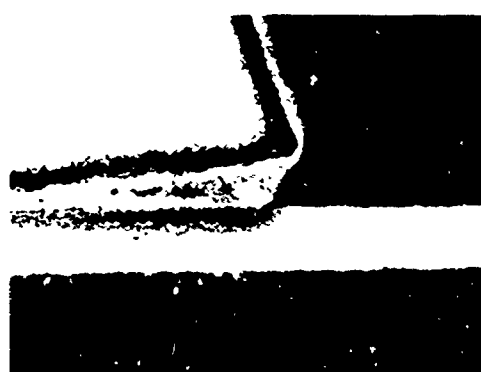
Figure 3. Photomicrographs of Inconel 625 Tube-Header Joints Brazed with Engelhard 135 Brazing Alloy, in Hydrogen, with a 10 Minute Hold Time at Temperature. Etched with Kalling's Reagent.

MAG 50X 998

2025°F BRAZING TEMPERATURE

MAG 150X 999

MAG 50X 1000

2000°F BRAZING TEMPERATURE

MAG 150X 1001

MAG 150X 1003

1975°F BRAZING TEMPERATURE

On the basis of the hot corrosion tests, Englehard 135 and Microbraz 65 were eliminated because of poor corrosion resistance. Coast Metals 50B and Microbraz 135 had satisfactory hot corrosion resistance and brazing characteristics, warranting consideration for the cyclic temperature tests. All the Palniro brazing alloys, J-8100, and Microbraz 200 had excellent hot corrosion resistance and brazing characteristics.

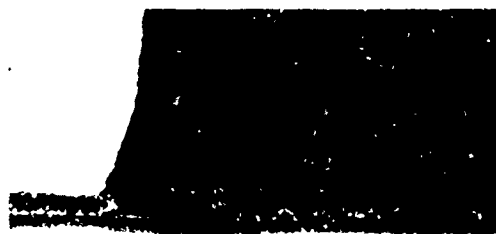
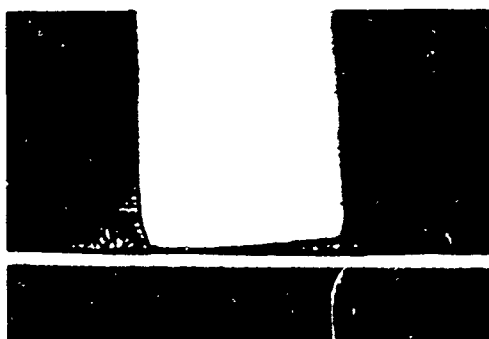
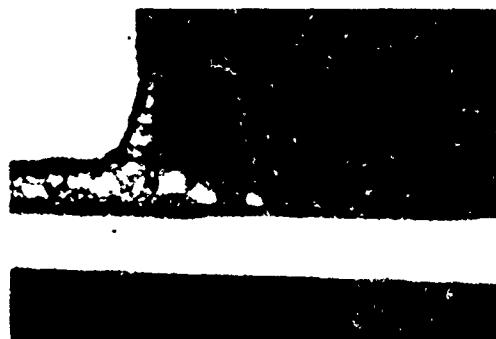
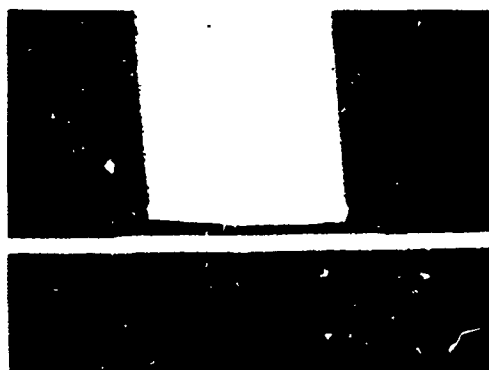
MAG = 150X 1005

b. 1975°F BRAZING TEMPERATURE.

MAG = 50X 1006

c. 1950°F BRAZING TEMPERATURE

MAG = 150X 1007

d. 1950°F BRAZING TEMPERATURE.

MAG = 50X 1008

e. 1925°F BRAZING TEMPERATURE.

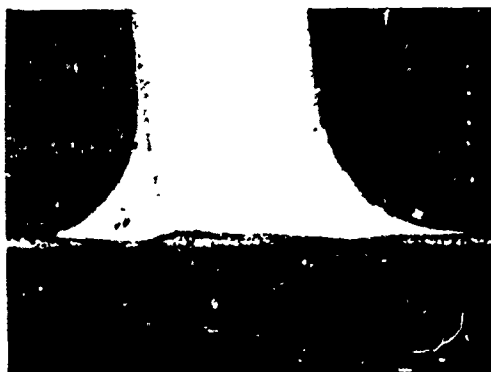
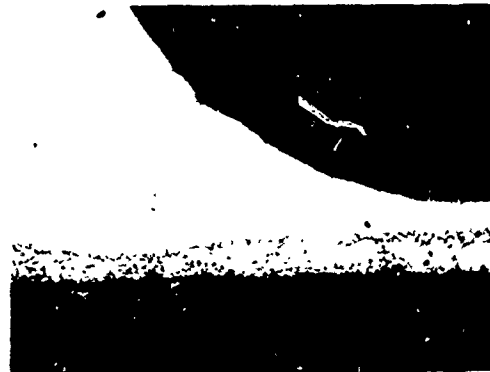
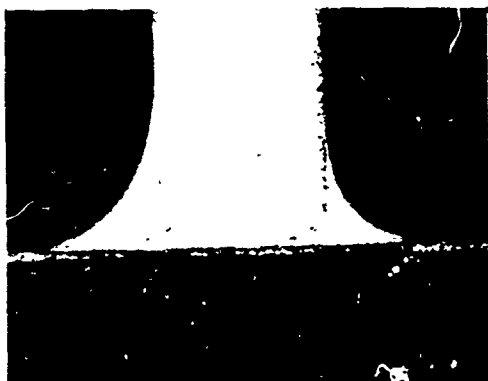
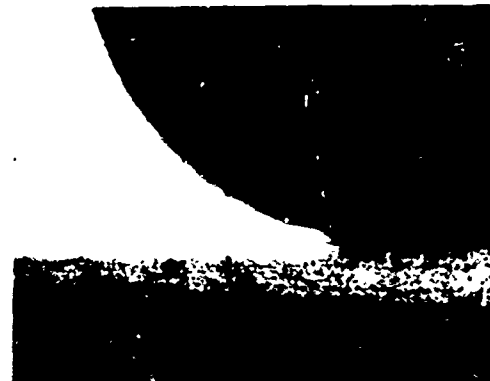
Figure 8. Photomicrographs of Inconel 625 Tube-Header Joints Brazed with Microbraz 65 Brazing Alloy, in Hydrogen, with a 10 Minute Hold Time at Temperature. Etched with Kalling's Reagent.

MAG 50X 1010

a. 2025°F BRAZING TEMPERATURE

MAG 150X 1011

b. 2025°F BRAZING TEMPERATURE

MAG 50X 1014

e. 1975°F BRAZING TEMPERATURE

MAG 150X 1015

f. 1975°F BRAZING TEMPERATURE

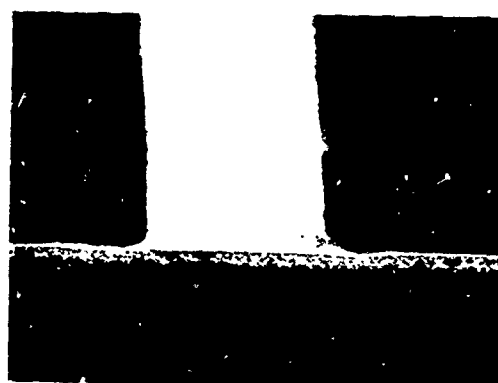
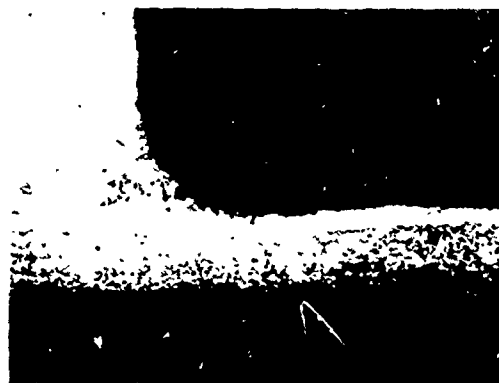
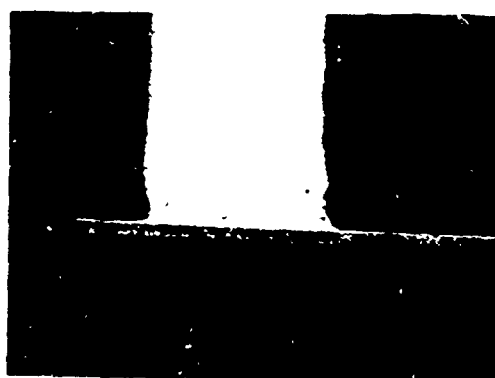
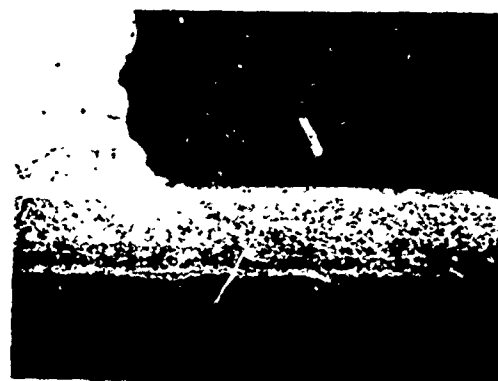
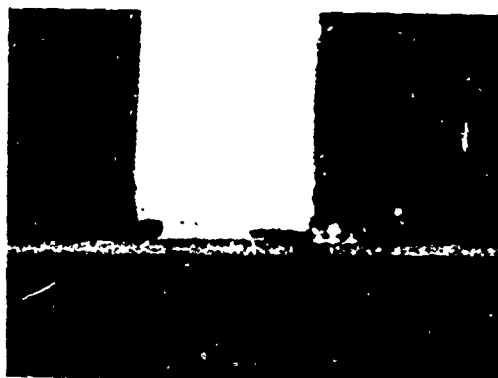
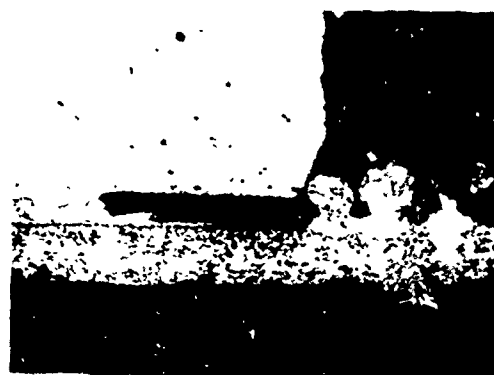
Figure 10. Photomicrographs of Incoloy 800 Tube-Header Joints Brazed With Microbraz 65 Brazing Alloy, in Hydrogen, with a 10 Minute Hold Time at Temperature. Etched with Kalling's Reagent.

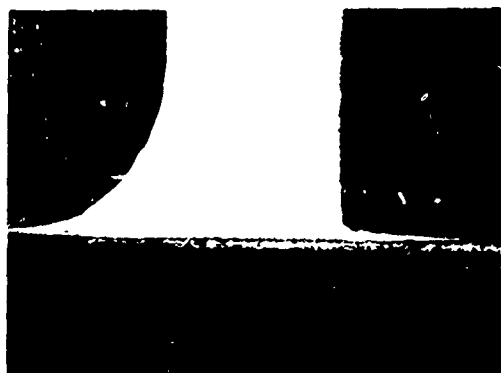
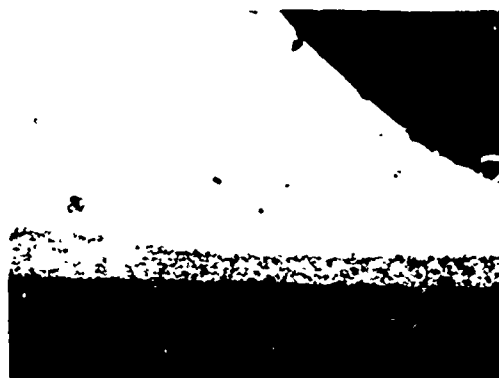
MAG 50X 1022
a. 1975°F BRAZING TEMPERATURE

MAG 150X 1027
f. 1925°F BRAZING TEMPERATURE

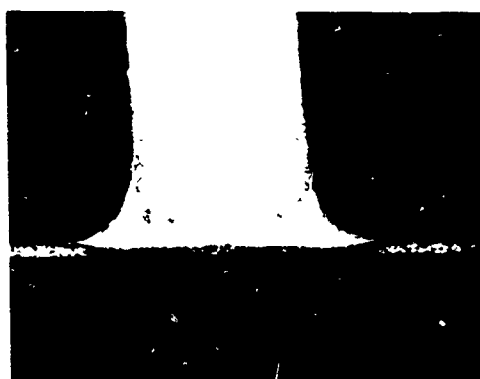
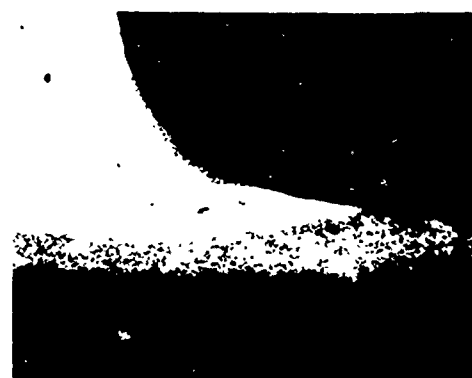
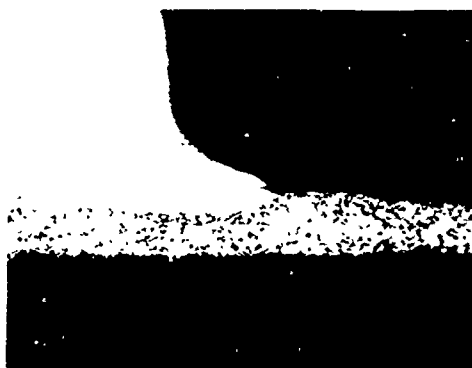
MAG = 50X 1030
c. 2050°F BRAZING TEMPERATURE.

MAG 150X 1031
d. 2050°F BRAZING TEMPERATURE.

MAG 150X 1033
f. 2025°F BRAZING TEMPERATURE

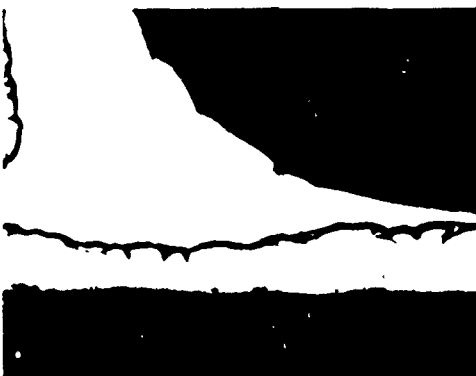
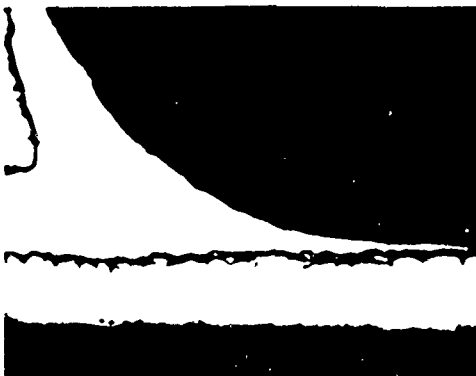
MAG = 150X 1037

d. 2175°F BRAZING TEMPERATURE.

MAG 150X 1039

f. 2150°F BRAZING TEMPERATURE.

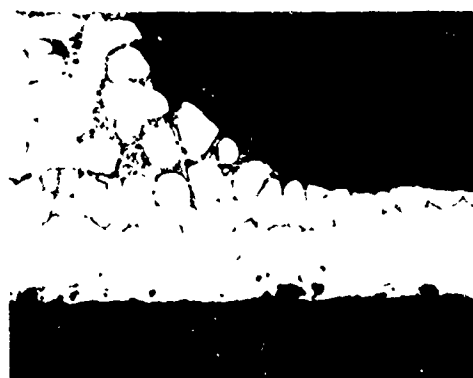
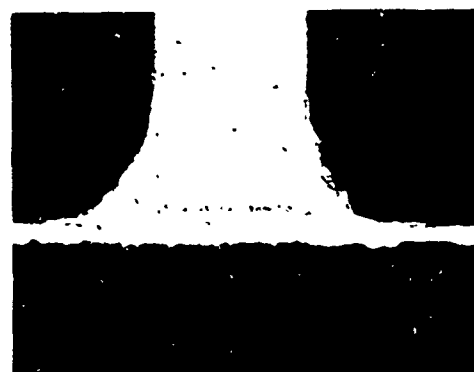
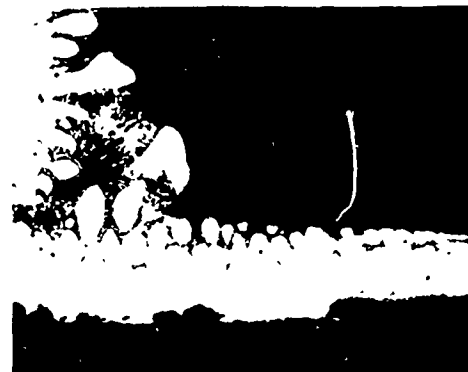
b. 2175°F BRAZING TEMPERATURE.

e. 2125°F BRAZING TEMPERATURE.

f. 2125°F BRAZING TEMPERATURE.

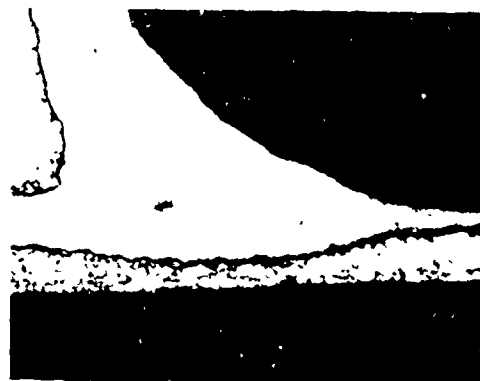
MAG 150X 1047

b. 2100°F BRAZING TEMPERATURE

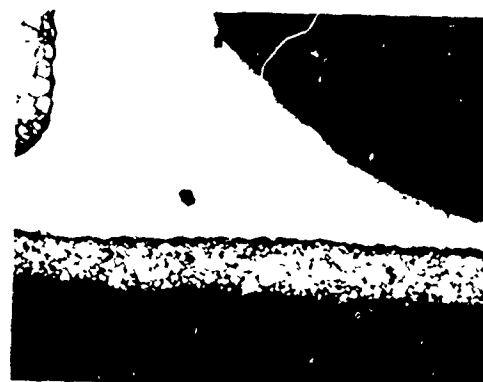
MAG 150X 1051

f. 2025°F BRAZING TEMPERATURE

Figure 15. Photomicrographs of Multimet N-155 Tube-Header Joints Brazed with Palniro 1 Brazing Alloy, in Vacuum, with a 10 Minute Hold Time at Temperature. Etched with Kalling's Reagent.

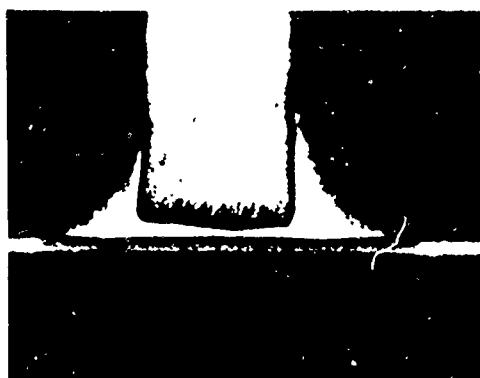
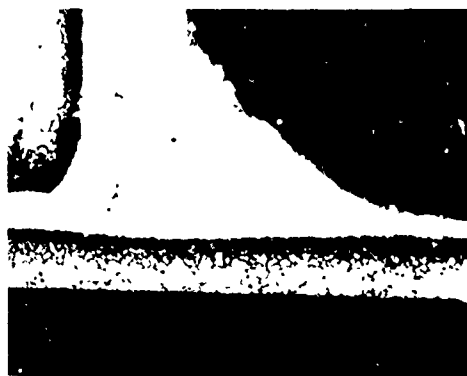
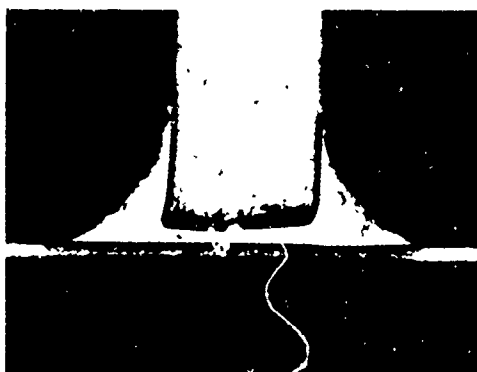
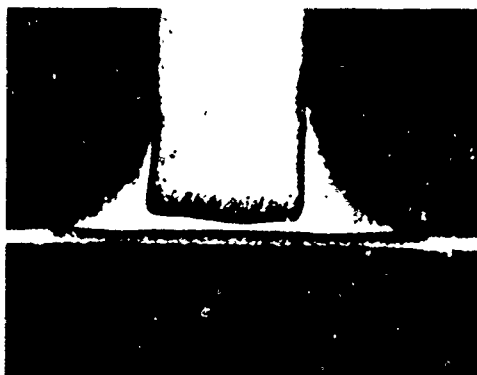
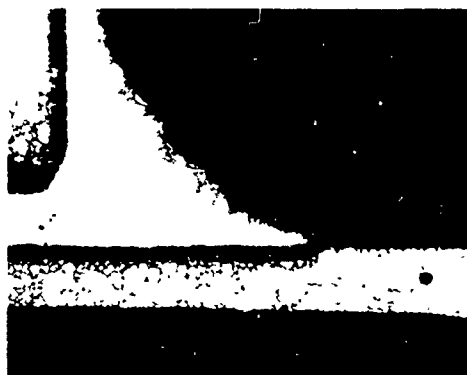
MAG 50X 1052
a. 1975°F BRAZING TEMPERATURE.

MAG 150X 1053
b. 1975°F BRAZING TEMPERATURE.

MAG 50X 1054
c. 1950°F BRAZING TEMPERATURE.

MAG 50X 1056
e. 1925°F BRAZING TEMPERATURE.

MAG 150X 1057
f. 1925°F BRAZING TEMPERATURE.

Figure 16. Photomicrographs of Multimet N-155 Tube-Header Joints Brazed with Microbraz 200 Brazing Alloy, in Vacuum, with a 10 Minute Hold Time at Temperature. Etched with Kalling's Reagent.

- N-155 - Palniro 1 had good brazing characteristics and excellent hot corrosion resistance. It was selected for brazing N-155 for the same reasons as for brazing Hastelloy X. Microbraz 200 also had good brazing characteristics and excellent hot corrosion resistance. Alloying and penetration of the N-155 by Microbraz 200 was only about 0.001 in. which should be satisfactory for this application.

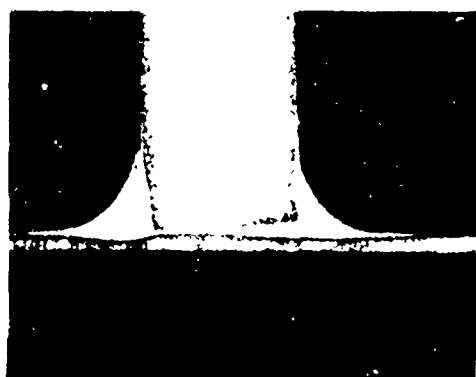
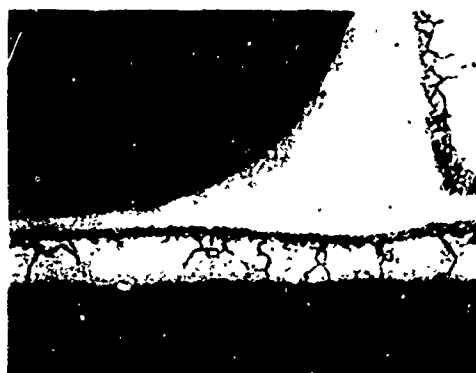
a. 2025°F BRAZING TEMPERATURE.

e. 1975°F BRAZING TEMPERATURE.

f. 1975°F BRAZING TEMPERATURE.

Figure 17. Photomicrographs of 347 CRES Tube-Header Joints Brazed with Microbraz 135 Brazing Alloy, in Vacuum, with a 10 Minute Hold Time at Temperature. Etched with Kalling's Reagent.

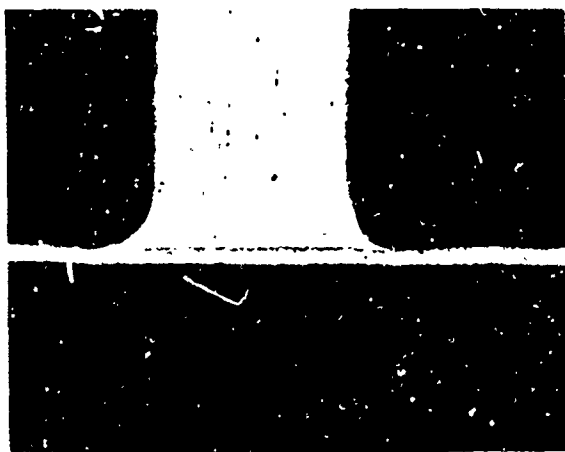
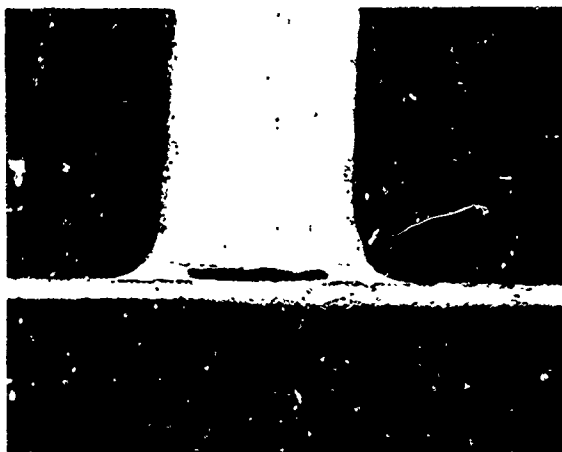
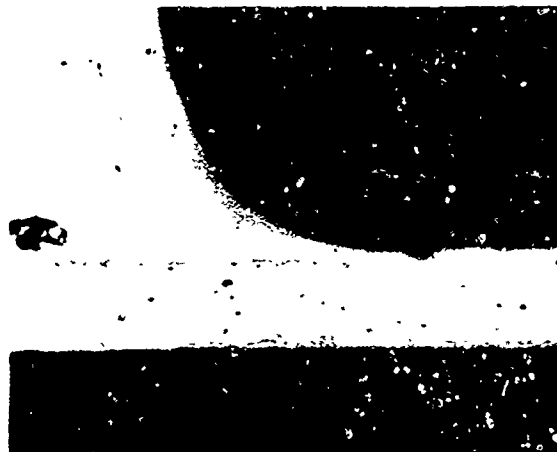
1075°F BRAZING TEMPERATURE

1950°F BRAZING TEMPERATURE

Figure 18. Photomicrographs of 347 CRES Tube-Header Joints Brazed with Microbraz 65 Brazing Alloy, in Hydrogen, with a 10 Minute Hold Time at Temperature. Etched with Kalling's Reagent.

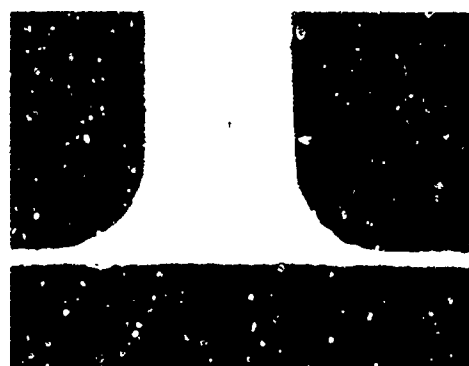
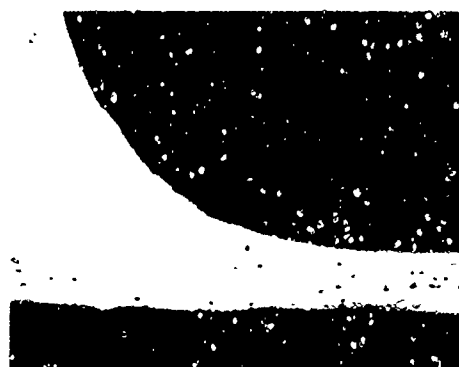
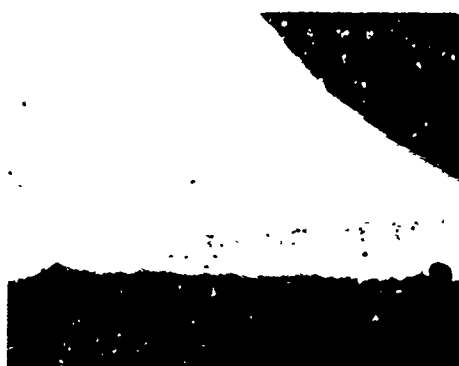
1900°F BRAZING TEMPERATURE

1915°F BRAZING TEMPERATURE

Figure 19. Photomicrographs of 347 CRES Tube-Header Joints Brazed with Palnir 7 Brazing Alloy, in Vacuum, with a 10 Minute Hold Time at Temperature. Etched with Kalling's Reagent.

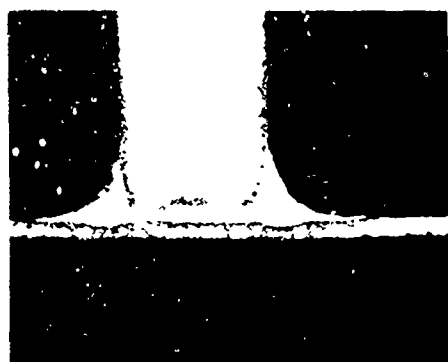
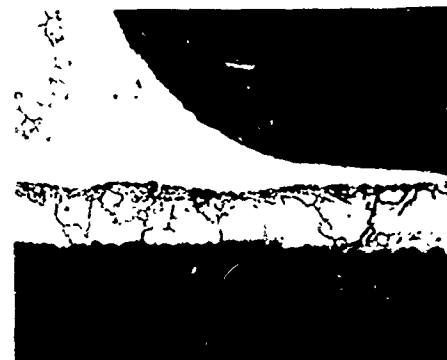
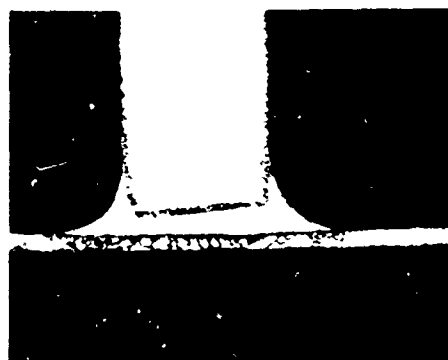
MAG = 50X 1072
2075°F BRAZING TEMPERATURE.

MAG 150X 1075
2050°F BRAZING TEMPERATURE

MAG 50X 1076
2025°F BRAZING TEMPERATURE

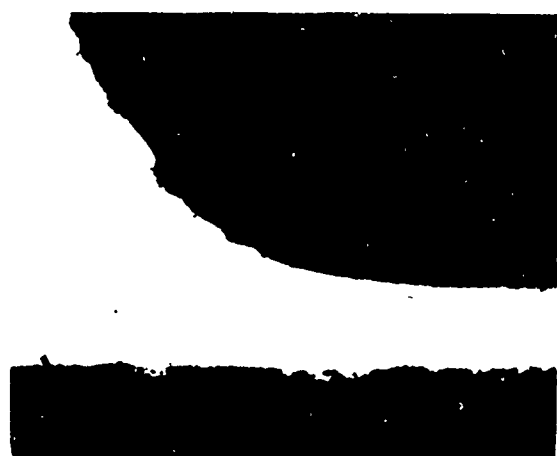
MAG 150X 1078

1. PALNIRO 4 BRAZING ALLOY, VACUUM
BRAZED AT 2170°F WITH HOLD
TIME OF 10 MIN. NO CORROSION OF
PALNIRO 4
NOTED.

Figure 21. Photomicrographs of Hastelloy X Tube-Header Joints Following Hot Corrosion Test at 1500°F for 100 Hours. No Corrosion Noted on Hastelloy X Tubing (1/8-in. O.D. x 0.0035-in. Wall).

The one-inch long tube-header samples were sectioned longitudinally and their microstructures examined for the effects of the static hot corrosion test. Photomicrographs of the brazed joints in the unetched condition are shown in Figure 21 through 25 inclusive. These show the resistance of the various tube material/filler metal combinations to the corrosive atmospheres at 1500°F for 100 hours.

- Hastelloy X - Palniro 1 had excellent brazing characteristics as noted in Table I. It also had excellent hot corrosion resistance. The 2075°F brazing temperature will permit retention of a fine grained structure. The J-8100 had good brazing characteristics and excellent hot corrosion resistance. Alloying was greater with J-8100 than Palniro 1 but still satisfactory. Grain growth occurred in Hastelloy X when brazing with J-8100. A fine grained structure has better tensile and fatigue properties, but lower stress-rupture properties. Selection of these two brazing alloys will afford a comparison between fine and coarse grain material in Task I-D tests. These two brazing alloys have previously been evaluated for a similar application in a lightweight heat exchanger operating at 1540°F maximum temperature. Both alloys performed equally well in axial tensile and axial fatigue tests at room temperature and 1540°F. Failures occurred in the tubing (1/8 in. O.D. x 0.003 in. wall) away from the brazed joint.

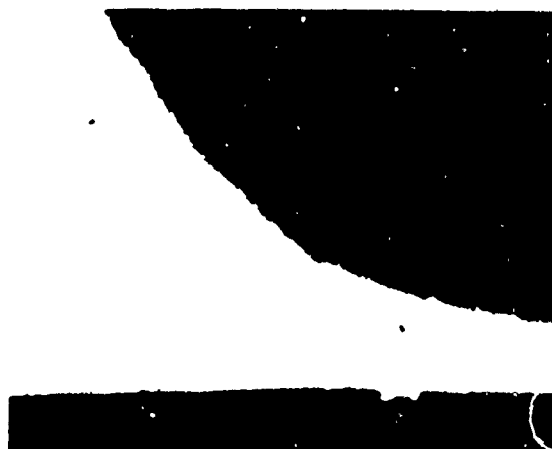
MAG 150X 1079

2. J-8100 BRAZING ALLOY, VACUUM
BRAZED AT 2150°F WITH HOLD
TIME OF 10 MIN. NO CORRO-
SION OF J-8100
NOTED.

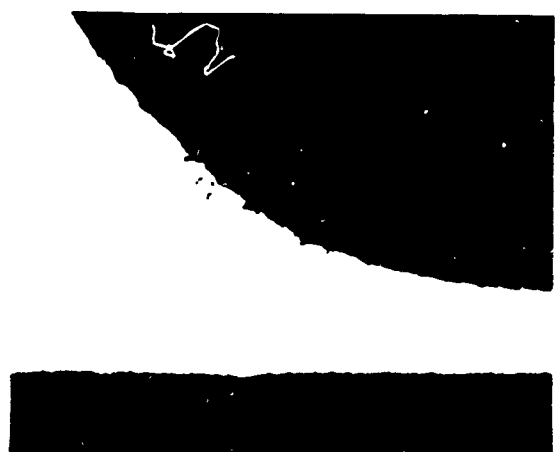
MAG 150X 1080

3. PALNIRO 1 BRAZING ALLOY, VACUUM
BRAZED AT 2070°F WITH HOLD
TIME OF 10 MIN. NO CORROSION OF
PALNIRO 1
NOTED.

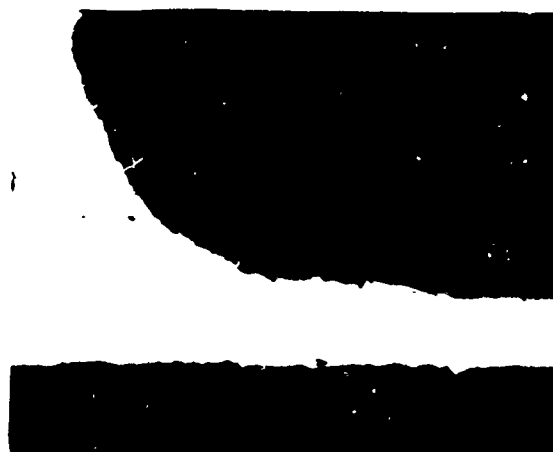
MAG 150X 1081

4. MICROBRAZ 151 BRAZING ALLOY,
VACUUM BRAZED AT 2000°F WITH
HOLD TIME OF 10 MIN. SOME
CORROSION OF MICROBRAZ 151'S
NOTED.

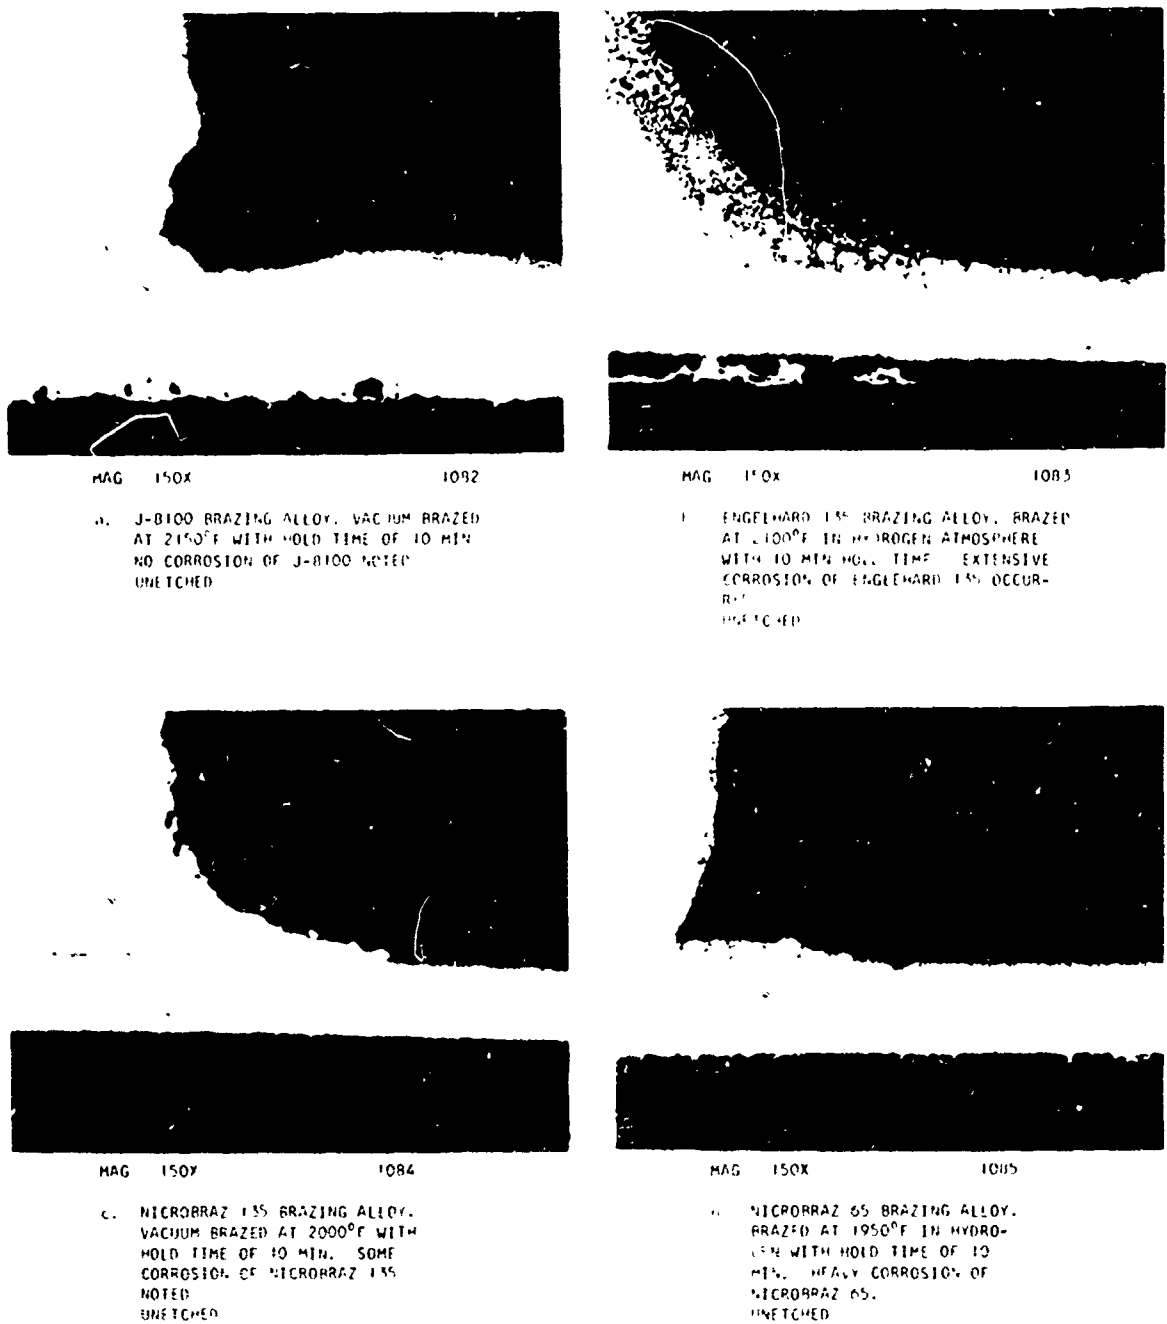
Figure 22. Photomicrographs of Inconel 625 Tube-Header Joint Following Hot Corrosion Test at 1500°F for 100 Hours. No Corrosion Noted on Inconel 625 Tubing (1/8-in. O.D. x 0.0035-in. Wall).

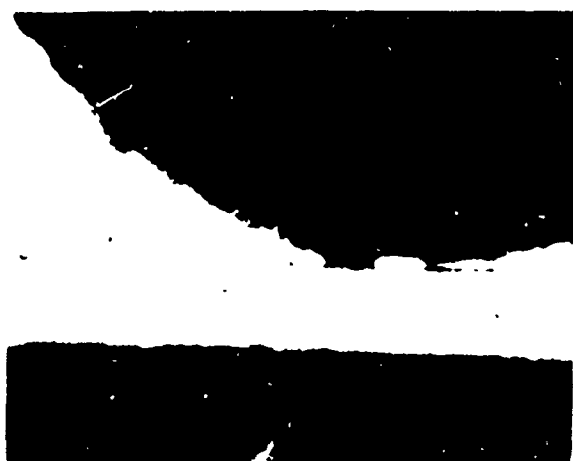
MAG 150X

a. MICROBRAZ 135 BRAZING ALLOY. VACUUM BRAZED AT 2000°F WITH 10 MIN HOLD TIME. SOME CORROSION OF MICROBRAZ 135 NOTED. UNETCHED

Figure 23. Photomicrographs of Incoloy 800 Tube-Header Joints Following Hot Corrosion Test at 1500°F for 100 Hours. No Corrosion Noted on Incoloy 800 Tubing (1/8-in. O.D. x 0.0035-in. Wall).

- Incoloy 800 - The basis for selecting Palniro 7 for Incoloy 800 was excellent brazing characteristics, hot corrosion resistance, and retention of a fine grain structure. Coast Metals 50B permitted some grain growth in Incoloy 800, alloyed somewhat more than Nicrobraz 135, but penetrated less than Nicrobraz 135. Within the brazing temperature evaluated, Coast Metals 50B had less overall alloying and penetration with Incoloy 800 than Nicrobraz 135 and was selected as a second choice.

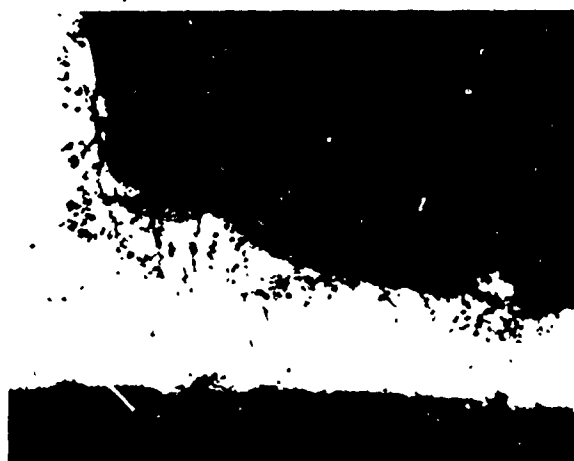
MAG 150X

b. MICROBRAZ 65 BRAZING ALLOY. BRAZED AT 1950°F IN HYDROGEN WITH 10 MIN HOLD TIME. EXTENSIVE CORROSION OF MICROBRAZ 65. UNETCHED

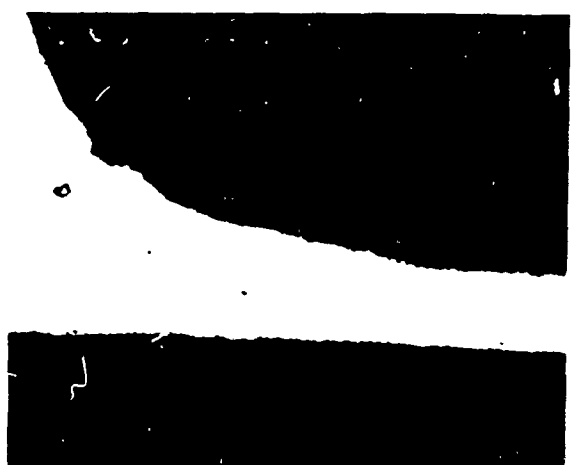
MAG 150X

c. PALNIRC 7 BRAZING ALLOY. VACUUM BRAZED AT 1950°F WITH 10 MIN HOLD TIME. NO CORROSION OF PALNIRC 7 NOTED. UNETCHED

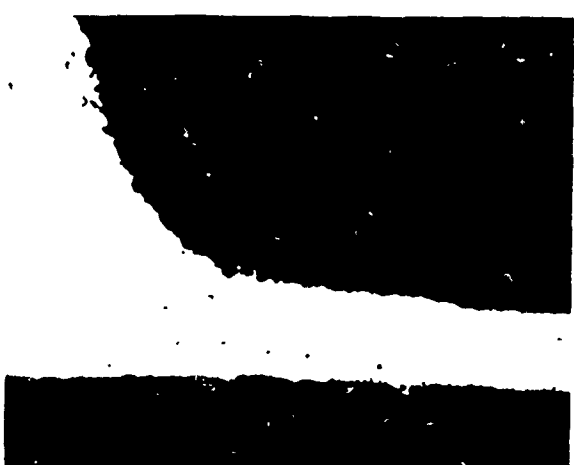
MAG 150X

d. COAST METALS 50R BRAZING ALLOY. VACUUM BRAZED AT 2050°F WITH 10 MIN HOLD TIME. SOME CORROSION OF 50R NOTED. UNETCHED

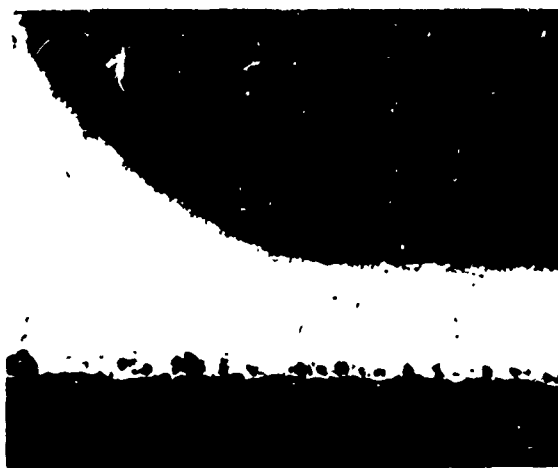
MAG 150X

A FALNRO 4 BRAZING ALLOY. VACUUM BRAZED AT 2175°F WITH 10 MIN HOLD TIME. NEGLIGIBLE CORROSION OF FALNRO 4 NOTED. UNETCHED

Figure 24. Photomicrographs of Multimet N-155 Tube-Header Joints Following Hot Corrosion Test at 1500°F for 100 Hours. No Corrosion Noted on Multimet N-155 Tubing (1/8 in. O.D. x 0.0035 in. Wall).

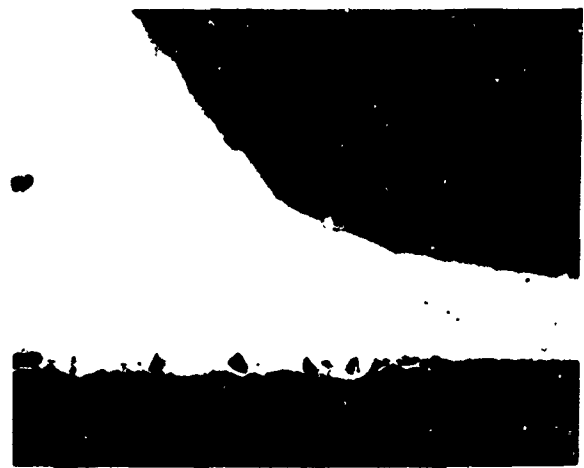
MAG 150X

B J-3100 BRAZING ALLOY. VACUUM BRAZED AT 2150°F WITH 10 MIN HOLD TIME. NO CORROSION OF J-3100 NOTED. UNETCHED

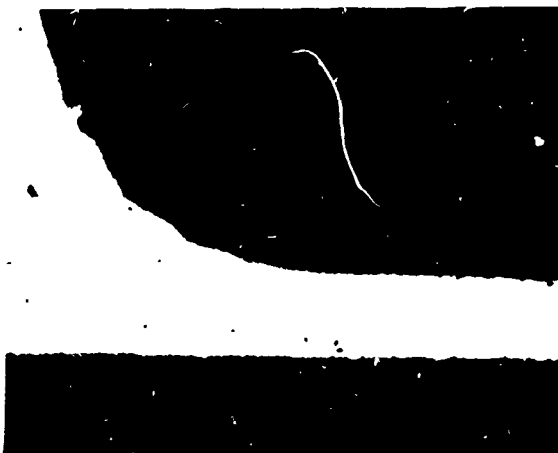
MAG 150X

C FALNRO 1 BRAZING ALLOY. VACUUM BRAZED AT 2075°F WITH 10 MIN HOLD TIME. NO CORROSION OF FALNRO 1 NOTED. UNETCHED

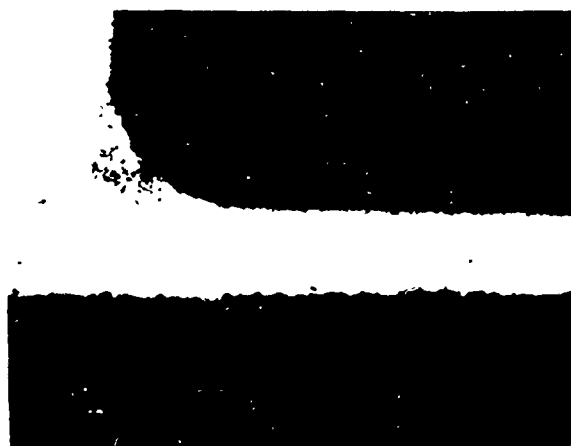
MAG 150X 1095

b. MICROBRAZ 25 BRAZING ALLOY, BRAZED AT 1900°F IN HYDROGEN WITH 10 MIN HOLD TIME. CORROSION OF MICROBRAZ 25 NOTED. UNETCHED

Figure 25. Photomicrographs of 347 CRES Tube-Header Joints Following Hot Corrosion Test at 1500°F for 100 Hours. The 347 CRES Tubing (1/8 in. O.D. x 0.0035 in. Wall) was Attacked to a Depth of Approximately 0.0015 in.

With the exception of the CRES 347, none of the other tube-header joints showed more than superficial corrosion. The stainless steel however was more heavily oxidized, as can be seen in Figure 25. Palniro 4, J-8100, Palniro 1, Palniro 7 and Microbraz 200 filler metals were not attacked by the sulphurous atmosphere. Microbraz 135 and Coast Metals 50B suffered moderate attack, but Microbraz 65 and Englehard 135 were both severely corroded.

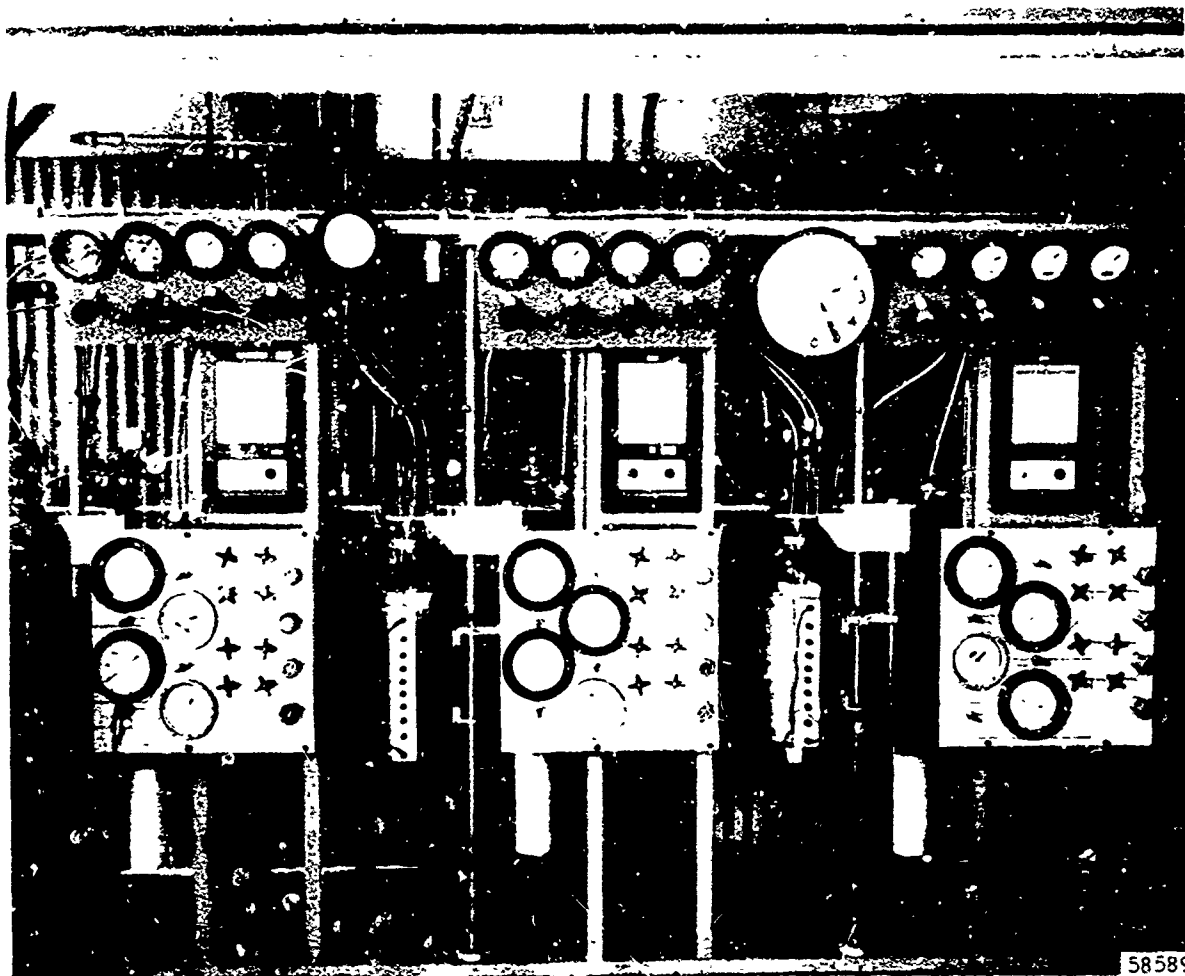
Figure 27 Tube Stress Rupture Test Rig

Tubing made from four materials (Hastelloy X, Inconel 800, Multimet N-55, CRES 347), each brazed with two different filler alloys, subject to a cyclic corrosive environment, will be pressurized at various levels to produce failure in approximately 75, 300 and 1000 hours. The tests are being conducted in three Marshall furnaces set-up as shown in Figure 27, maintaining metal temperatures of 1100, 1300 and 1500°F.
